Level 1, Platinum Reserve Analysis

Garage Town at Del Camino Storage Co., Inc.
3656 Stagecoach Rd.
Longmont, CO. 80504

FINAL VERSION

Date of Property Observation – January 6, 2023

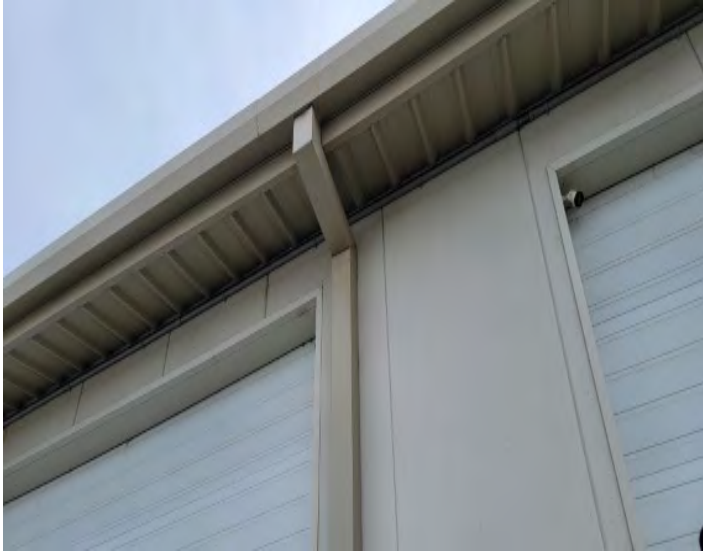
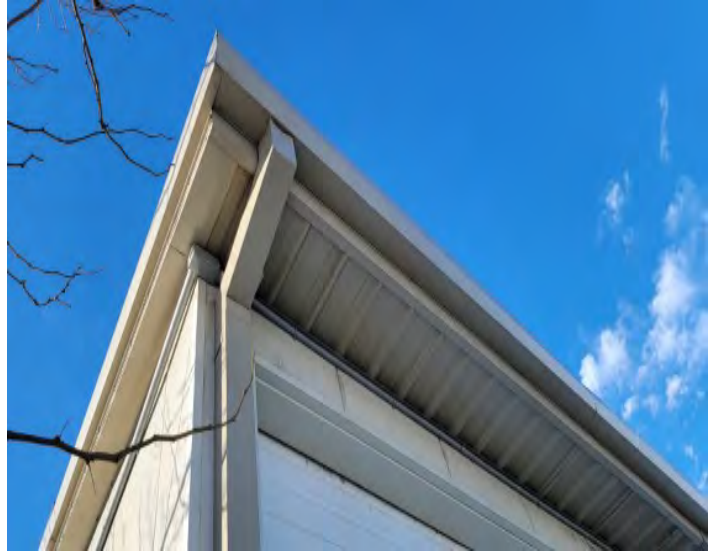
Comp #: 120 Gutters/Downspouts - Replace

- Damaged extensions can be replaced as needed with general operating funds.
- The life expectancy for the size of these gutters and downspouts should range between 25 - 30 years, depending on maintenance.
- Keep gutters and downspouts free from dirt and debris which can cause corrosion of metal materials or blockage which can cause the downspouts to freeze and expand during winter months.
- Remaining life is based on the age of the buildings

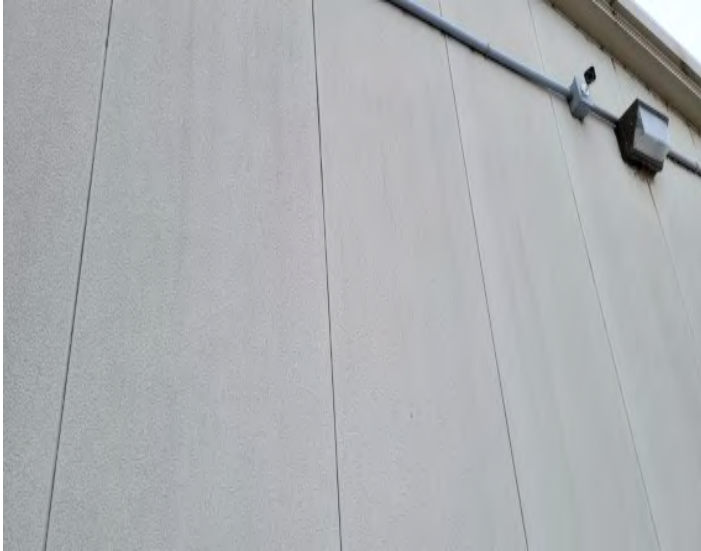
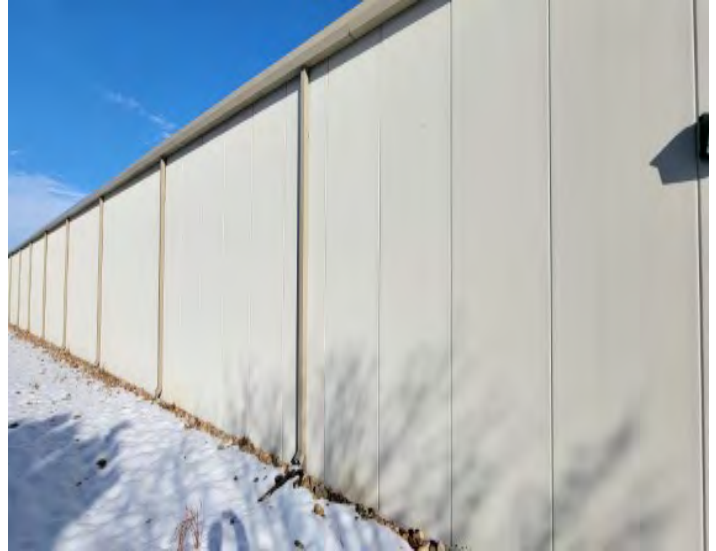
Comp #: 201 Stucco Surfaces - Repaint

- Stucco surfaces should typically be repainted approximately every 10 to 15 years to protect stucco surface and maintain appearance. - Remaining life based on current condition.
- However, this surface is in good condition after being installed about 18 years ago.
- There are some areas that have been "tagged" and the graffiti has been removed.
- However, this has deteriorated the stucco finish minimally.
- According to the manufacturer, this material has a 20-year finish warranty
- We recommend in order to maintain an appropriate appearance for these surfaces, the buildings are painted every 20 - 25 years

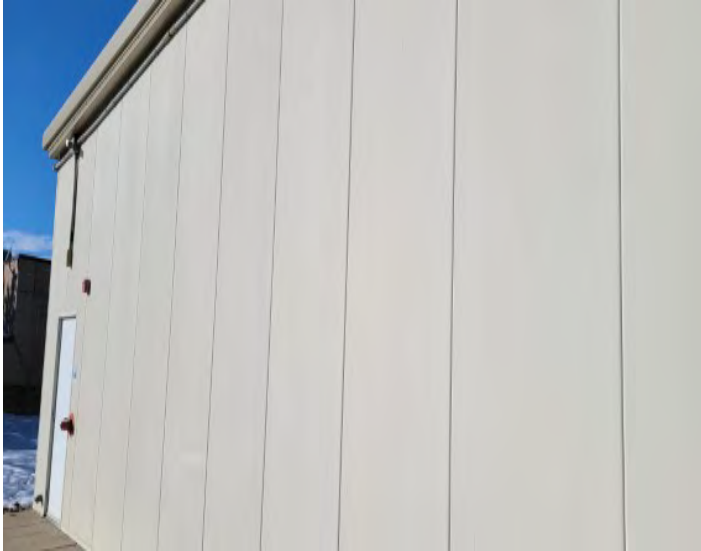
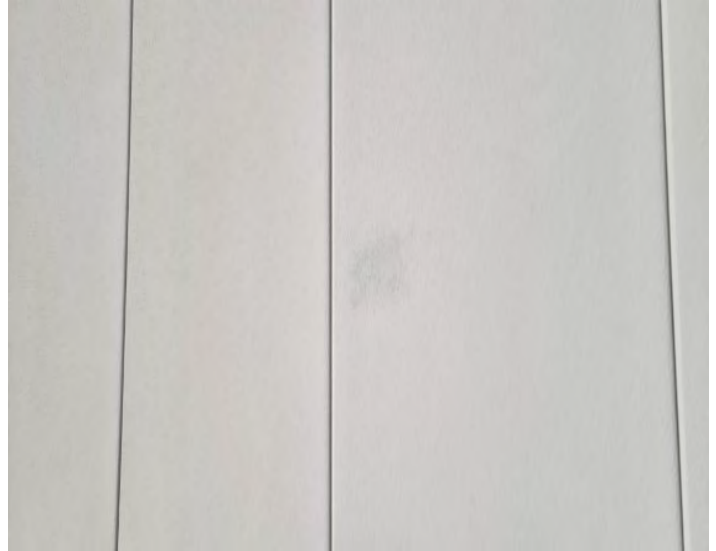
Comp #: 307 Stucco - Repair

- In general, the stucco is in good condition with little to no signs of deterioration.
- The only areas we noted damage was where stucco had to be pressure washed to remove graffiti from the walls.
- There was some evidence of minor scratches, but nothing that would require a major expense for repairs.
- This stucco is applied to a metal backing that has an extended life expectancy.
- Due to an indefinite life for this material, we do not recommend Reserve funding for this component

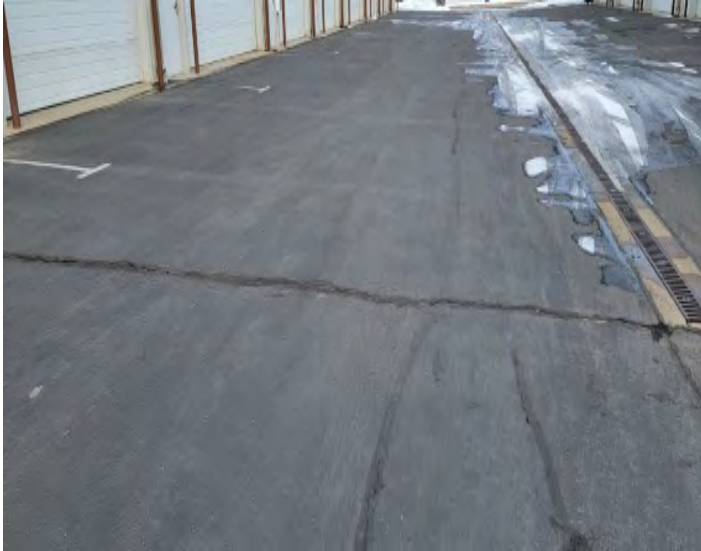
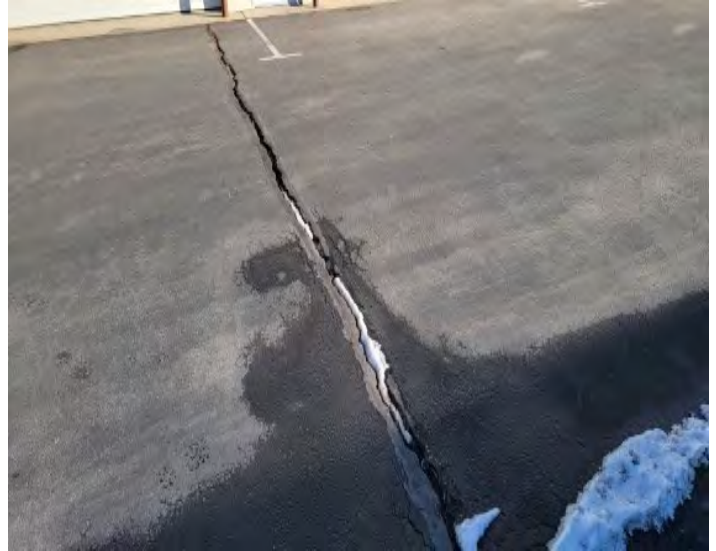
Comp #: 401 Asphalt - Major Overlay

- Asphalt has been well maintained with annual crack fill and periodic seal coating being performed.
- The average life expectancy for asphalt surfaces ranges between 20 - 27 years for surfaces that are maintained on a regular schedule.
- Maintenance includes crack fill and repairing small potholes annually as an operating expense.
- In addition, asphalt should be seal coated every 3 - 4 years, depending on the level of traffic and snow removing techniques.

- 2023 - \$2,986 (Repairs near trash enclosure and south end between bldgs 1 and 2)

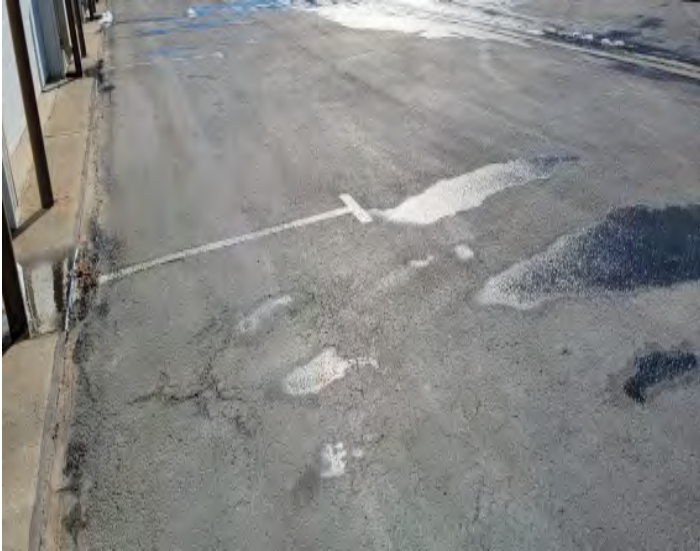
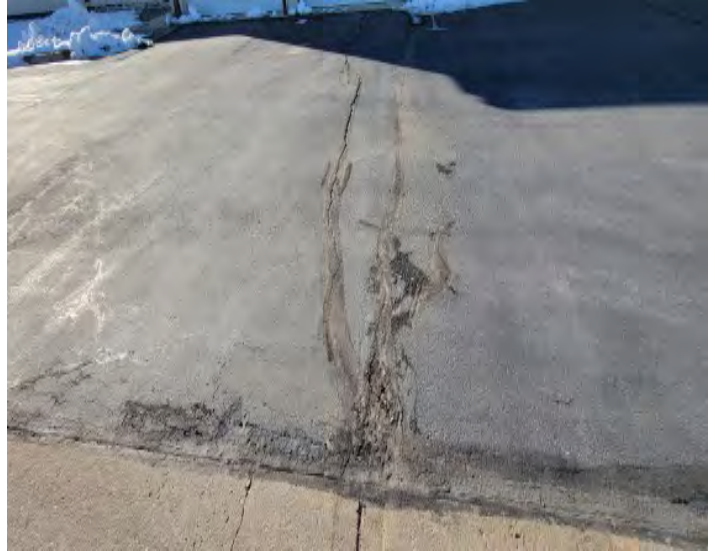
Comp #: 402 Asphalt - Surface Application

- Seal coated in 2021 and is in good to fair condition at time of site visit. The large cracks that were observed will be filled in January 2023.
- It is important to maintain a proper seal cycle to protect the integrity of the asphalt and prevent extensive cracking, development of potholes, and loss of emulsion, which will lead to advanced deterioration.
- Depending on the type of snow removal techniques and the level of traffic, we suggest seal coating every 2 - 3 years.
- In between seal cycles, the asphalt should be inspected and any cracking that develops should be filled, along with any minor repairs to prolong the life of the surface.

- 2021 - sealed all paved areas
- 2022 - \$3,547 (Crack seal approx. 2,700 LF in field and approx. 3,954 LF asphalt/concrete joints)

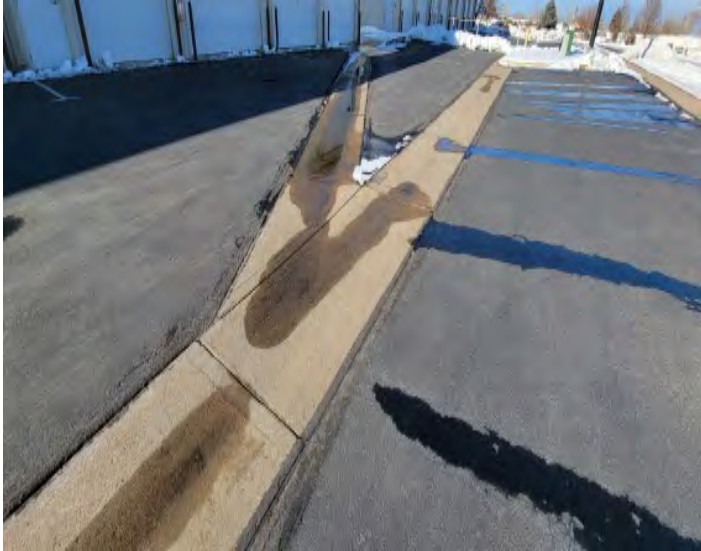
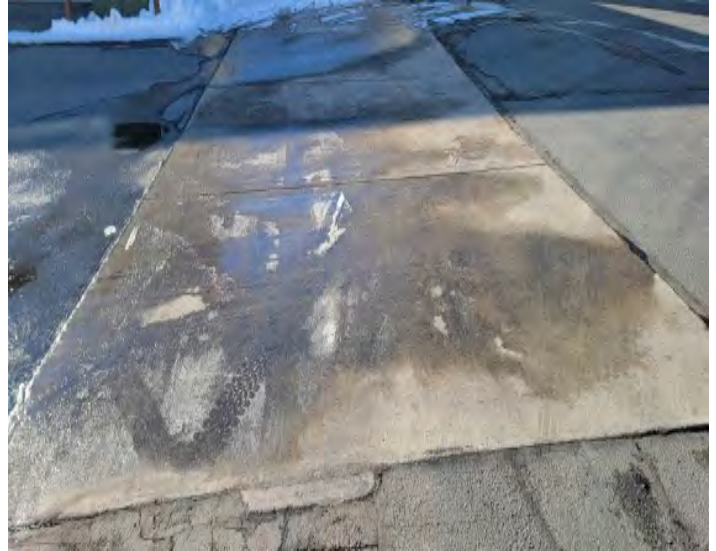
Comp #: 403 Concrete - Partial Replace

- Concrete is in good to fair condition, with no significant cracking or spalling noted at time of site visit.
- It is unlikely that all concrete will fail and need to be replaced at the same time.
- Therefore, we recommend reserving an allowance for periodic repairs to a percentage of the total area (15% of total area, or 875 GSF) every 6 years.
- Coordinate this project with other concrete and/or asphalt projects for best cost estimates based on quantity of work.
- This line item is not intended to be interpreted as complete replacement.

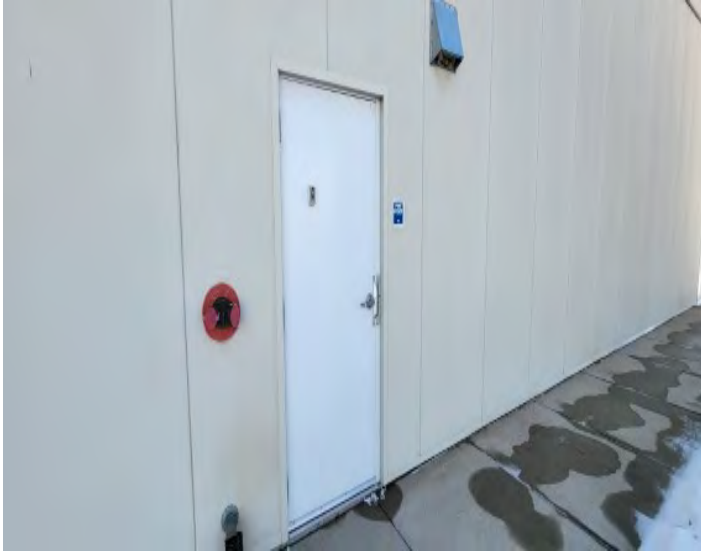
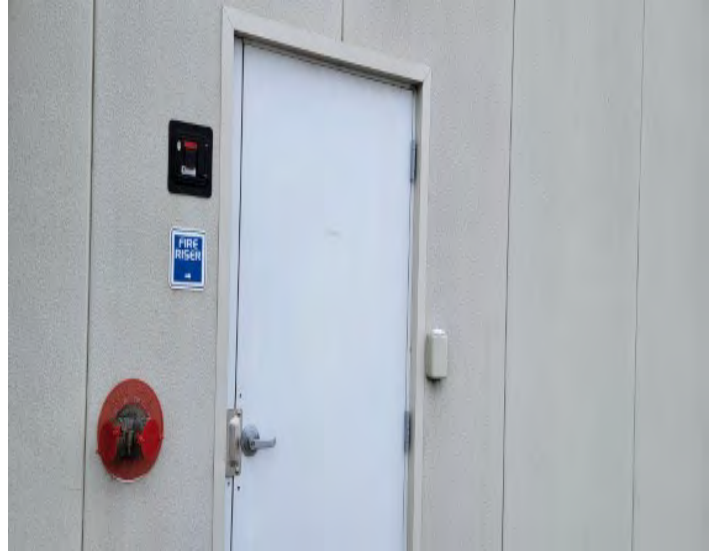
Comp #: 501 Common Steel Doors - Replace

- The average replacement cycle for exterior doors ranges between 20 - 30 years under normal conditions.
- These doors are exposed directly to elements, so a shorter life is possible.
- However, based on age of property and the observed conditions, we have established a replacement cycle of 27 years at this time.
- Continue to monitor and if conditions worsen more than anticipated, then adjust accordingly in future Reserve Study updates.
- Association should paint these common doors as needed with operating funds due to low quantity.
- Unit owners are responsible for their own man door, so Reserve funding is not required for those doors

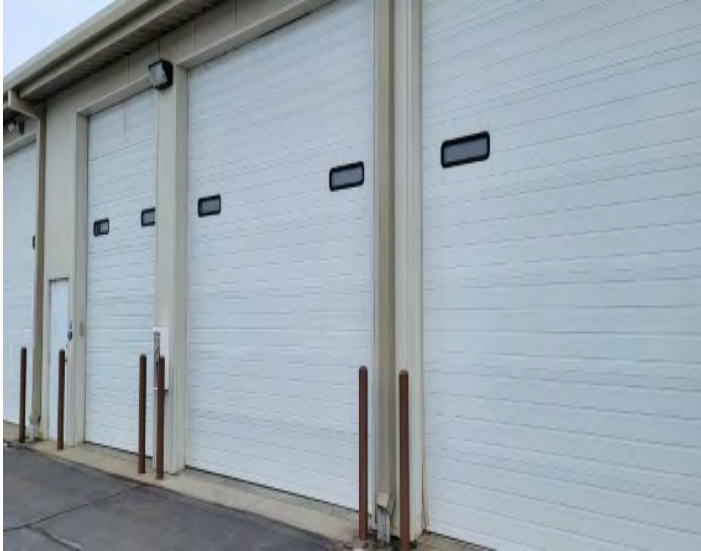
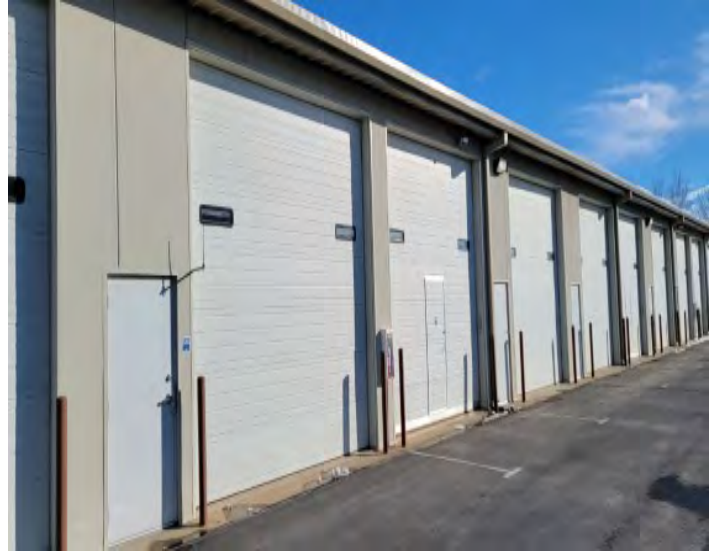
Comp #: 502 Garage Doors - Replace

- It has been reported that garage doors are the responsibility of the owner.
- Some associations decide to include garage doors as an association expense to obtain the best cost available and to maintain a consistent appearance for the association.
- Unless otherwise noted, Reserve funding will not be included based on the rules stated in the declarations.
- We suggest the association establish a design guideline so that when an owner goes to replace a door, it will match and be consistent with the others.

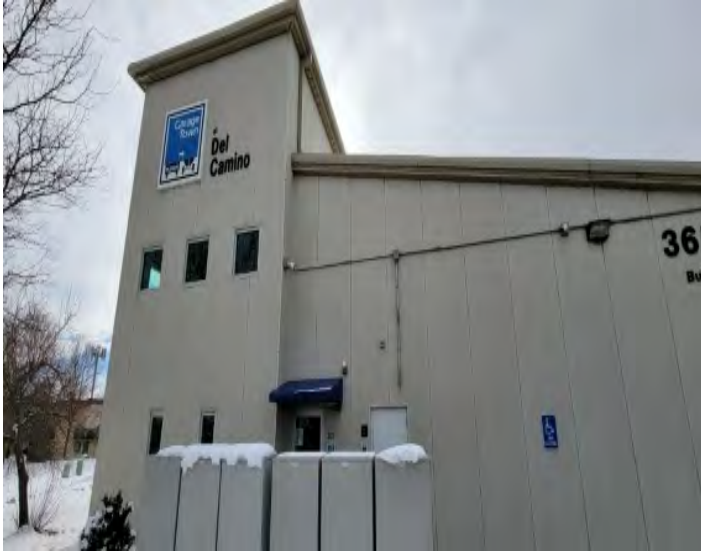
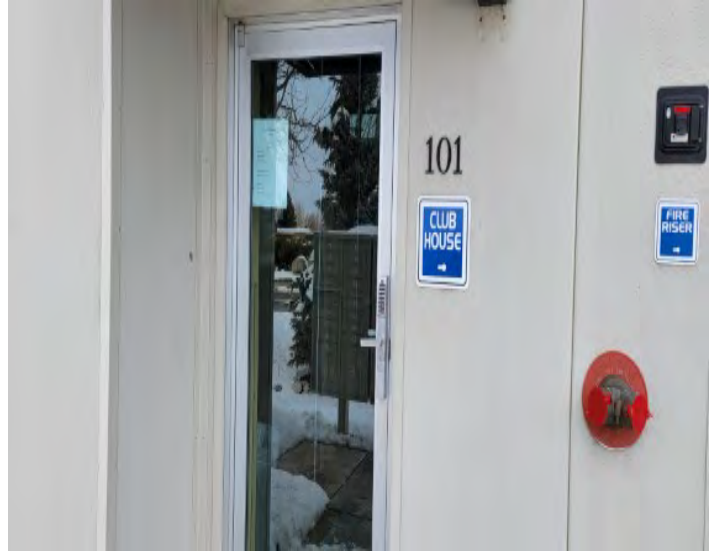
Comp #: 506 Windows - Replace

- No reported problems with leaks. Seals appear to be intact with no fogging of windows noted.
- In our experience, we have seen the need to replace common area windows and doors every 25 - 35 years on average.
- Remaining life is based on the age of the property

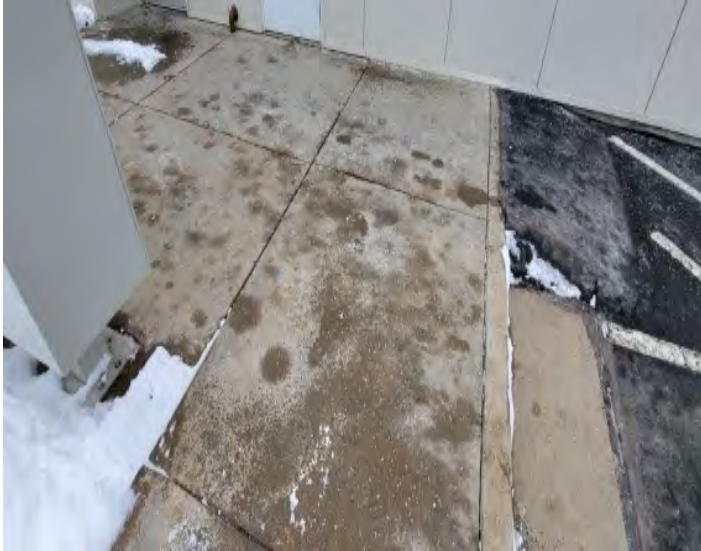
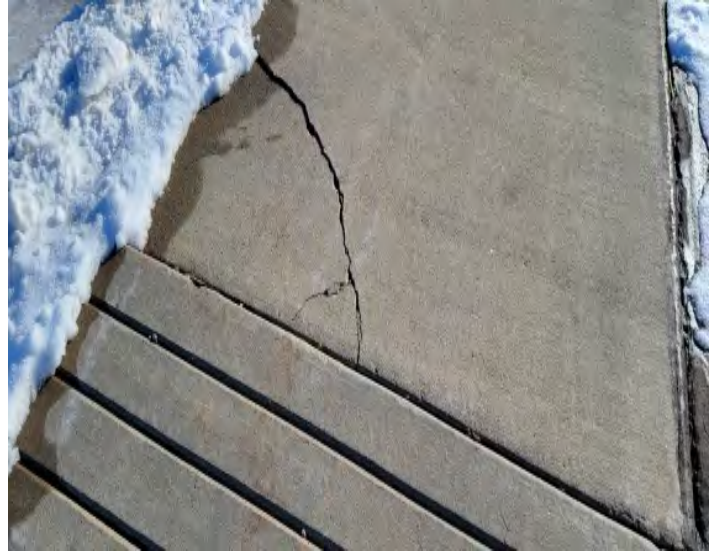
Comp #: 601 Concrete Flatwork - Partial Replace

- Similar to the concrete drive surfaces, it is unlikely all areas will fail and need to be replaced at the same time.
- Therefore, we set an allowance of 10% of the total area measured (1225 GSF) to be repaired every 6 years.
- As the property continues to age, it is possible the percentage or frequency of repairs will need to be adjusted in future Reserve Study updates.

- 2022 - \$2,637 (Replaced walkway north of building 1)

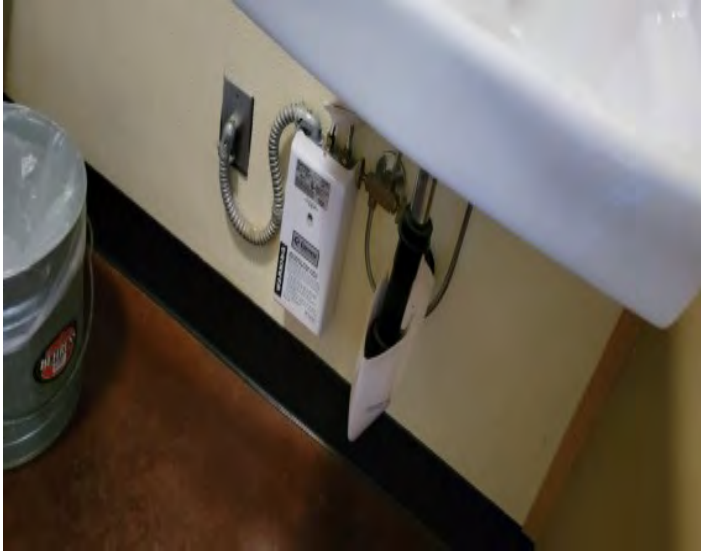
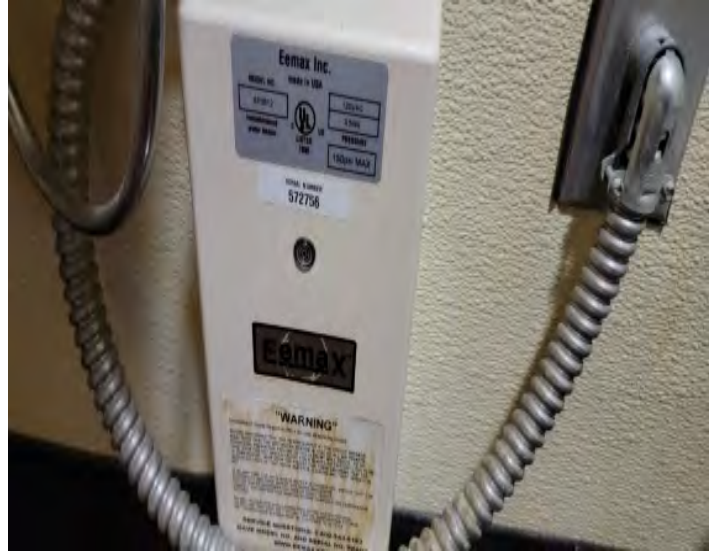
Comp #: 703 Water Heater - Replace

- Heaters were functional and in good operating condition with no reported problems. When tested, water heated up quickly.
- The replacement cost of these heaters (less than \$500 each) is too small for separate Reserve designation.
- Replace as needed with general operating funds.

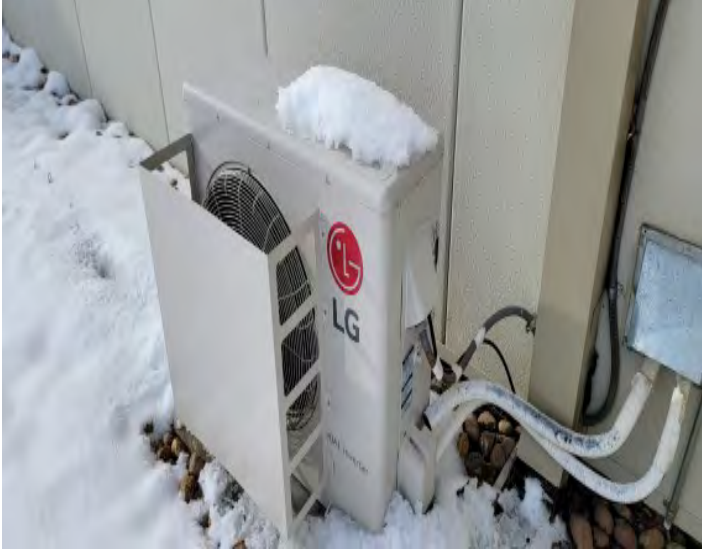
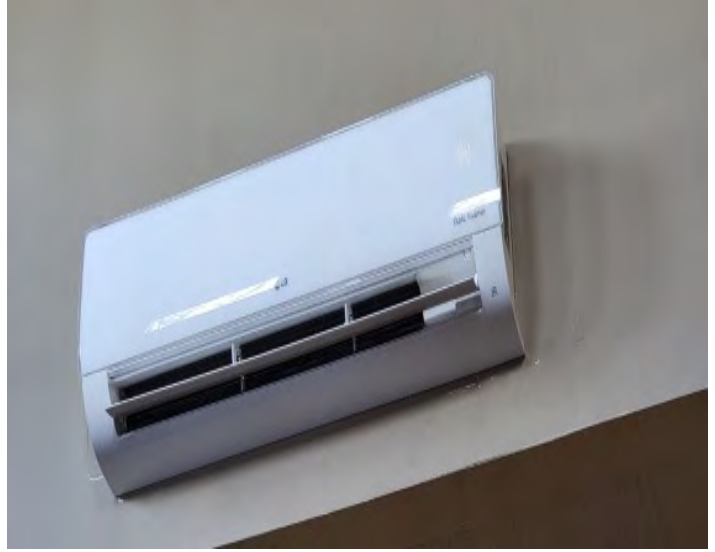
Comp #: 705 HVAC Split System - Replace

- System was installed within the past couple years and is working well with no reported issues.
- According to local contractors, the average life expectancy for these units ranges from 15 - 18 years
- The remaining life is based on the age of the system

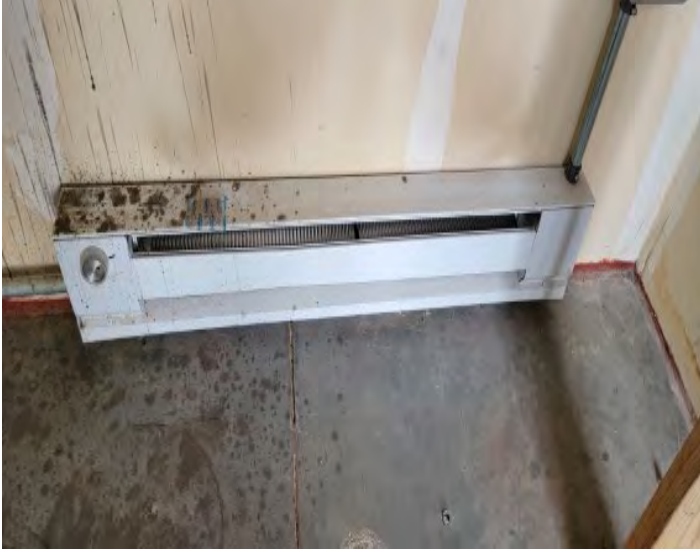
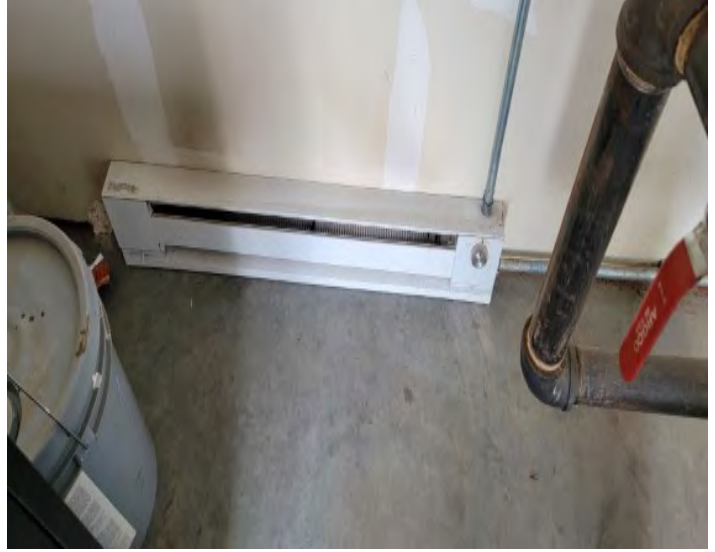
Comp #: 717 Baseboard Heaters - Replace

- Cost to replace small electric baseboard heaters is too small for Reserve designation.
- Replace as needed with general operating funds.

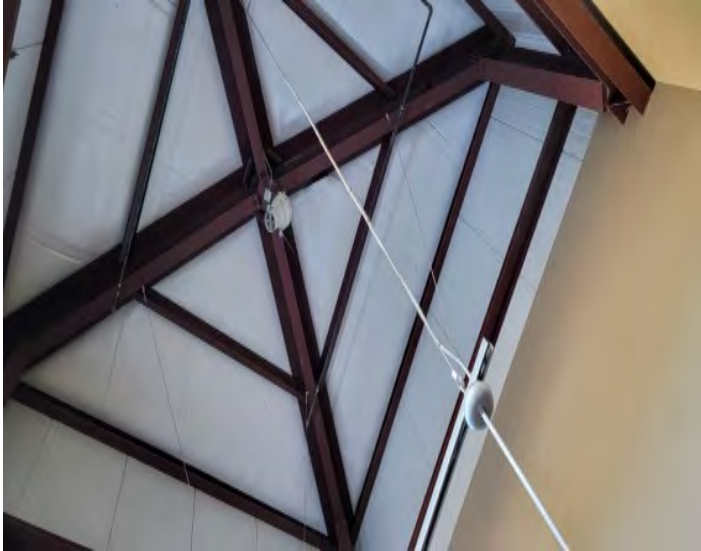
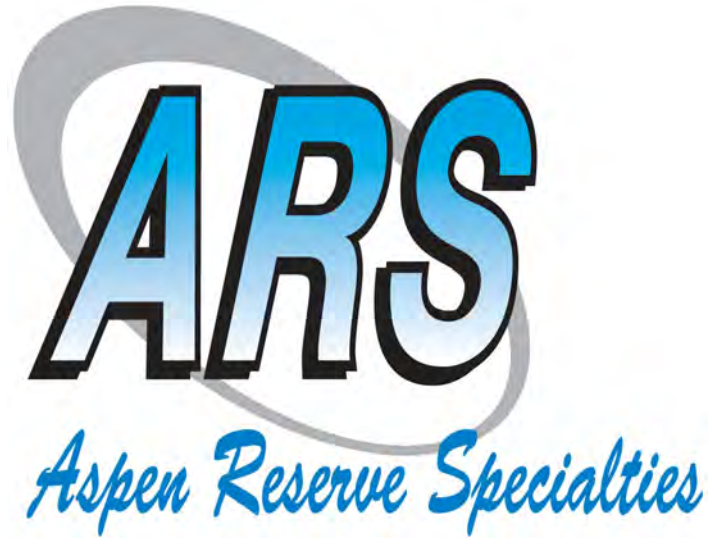
Comp #: 727 Air Circulator - Replace

- An air circulator (looks like a small fan) was installed at the top of the clubhouse tower for better air flow and to balance the temperature of the room better, so the air conditioner and heater doesn't work as hard.
- The cost for a new circulator is too small to use Reserve funds for replacement
- Replace as needed with operating funds.

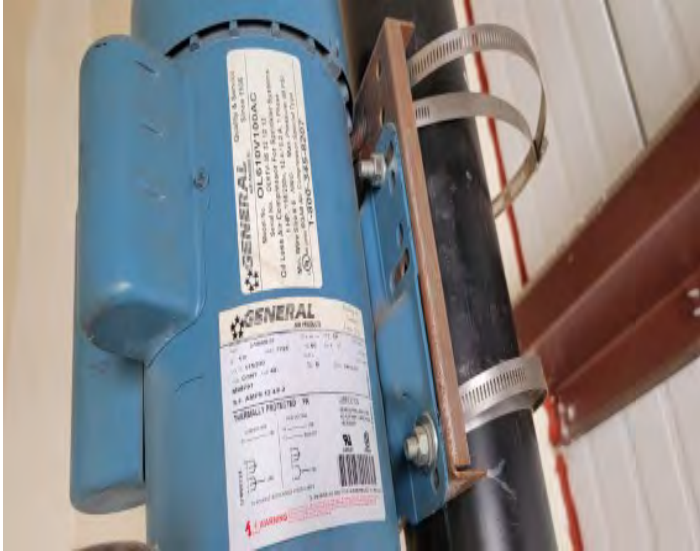
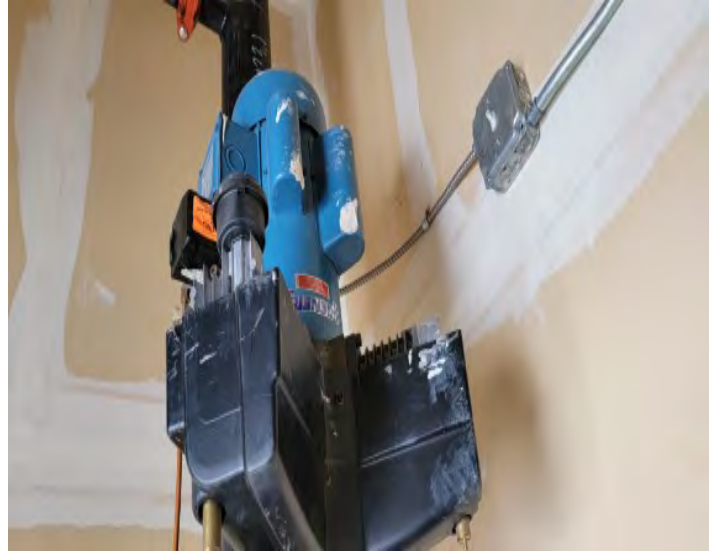
Comp #: 727 Air Compressor - Replace

- Compressors are functioning well with no noted issues with operation of units.
- The replacement cycle will depend on the amount of use and the quality of the units.
- We recommend the association plan on replacing every 10 - 12 years to ensure the system is operating when necessary

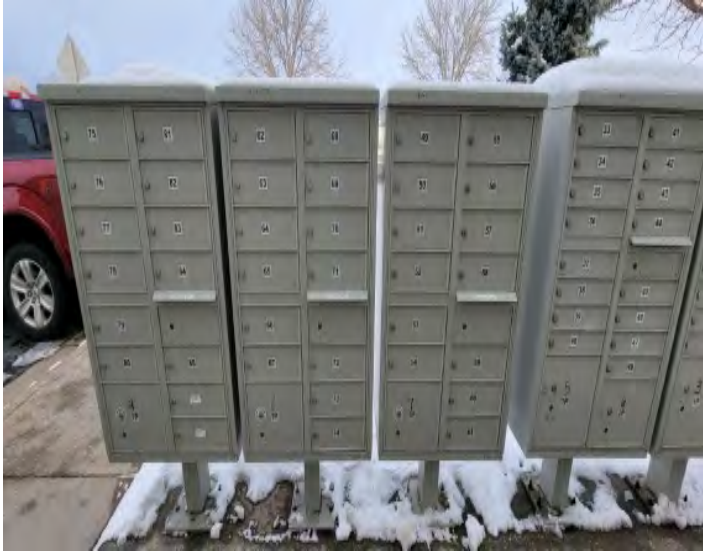
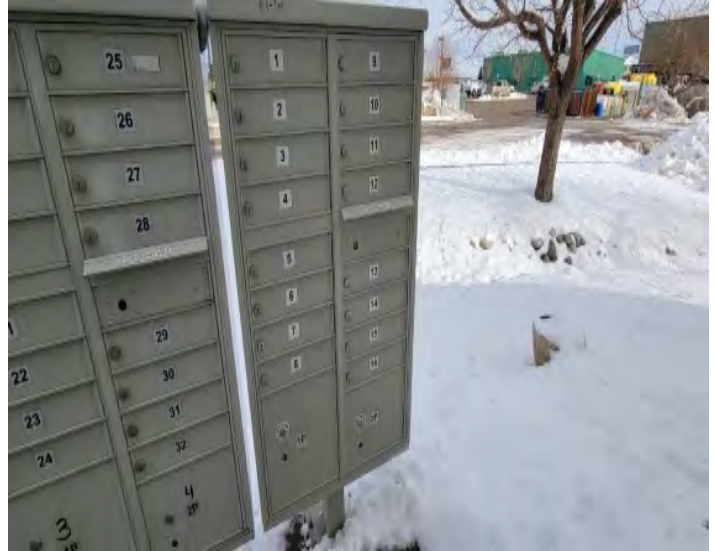
Comp #: 803 Mailboxes - Replace (New)

- These boxes were added in 2020 as the post office would not deliver mail to the property unless there was a slot for each unit owner.
- These are not used often as only a few owners get mail delivered to the property.
- However, as long as these remain as an asset for the community, we must Reserve for eventual replacement.
- According to several manufacturers, the typical life expectancy for this type of mailbox is 20 - 25 years in this environment.
- Remaining life is based on age of these units.

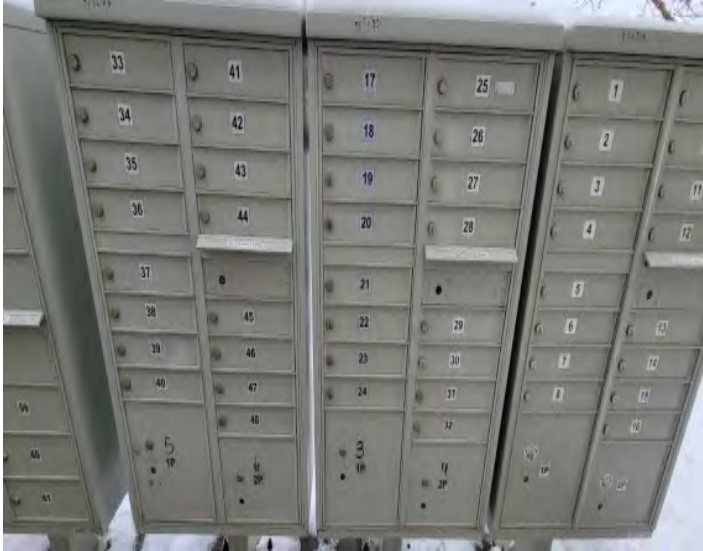
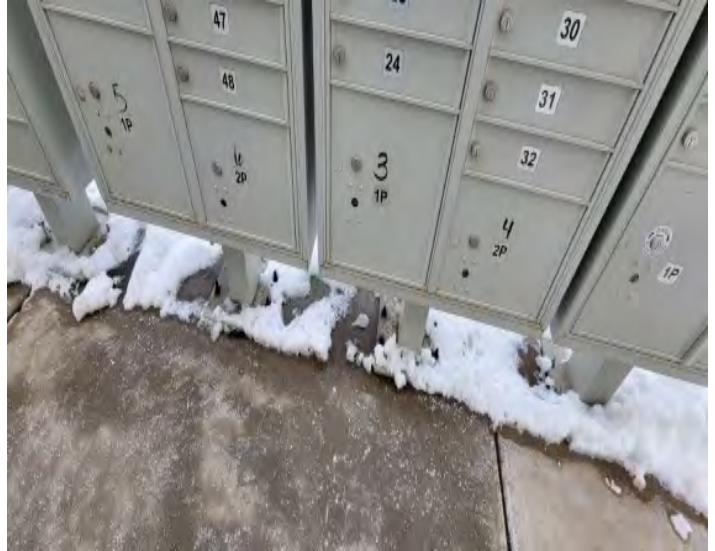
Comp #: 803 Mailboxes - Replace (Old)

- These boxes are original to the date of construction.
- These are not used often as only a few owners get mail delivered to the property.
- However, as long as these remain as an asset for the community, we must Reserve for eventual replacement.
- According to several manufacturers, the typical life expectancy for this type of mailbox is 20 - 25 years in this environment.
- Remaining life is based on age of these units.

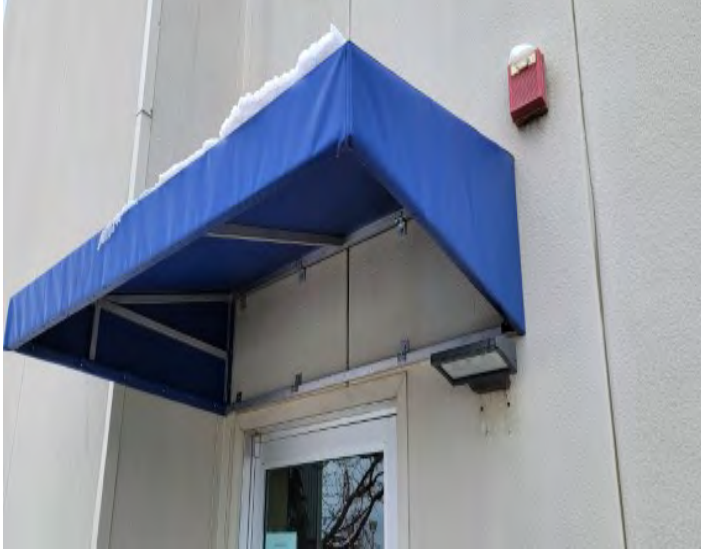
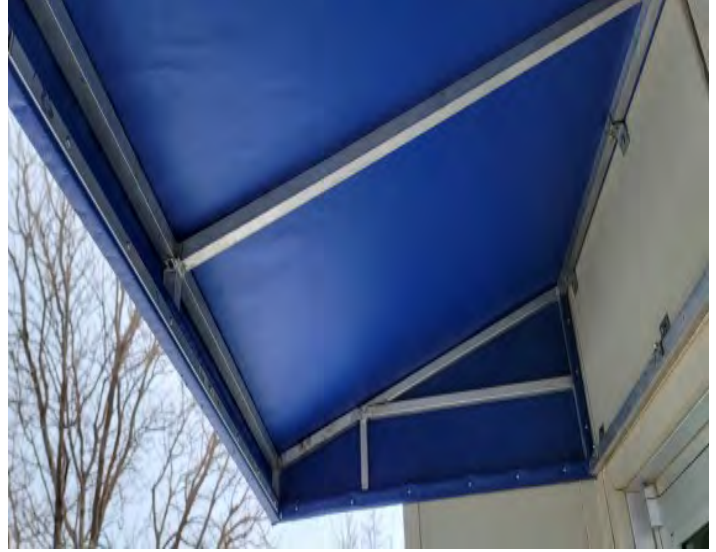
Comp #: 804 Awnings - Replace

- No rips or tears noted, no fading or discoloration observed.
- Expect to replace awning fabric every 6 - 8 years.
- The cost for the fabric is too small for Reserve designation.
- Replace with general operating funds.

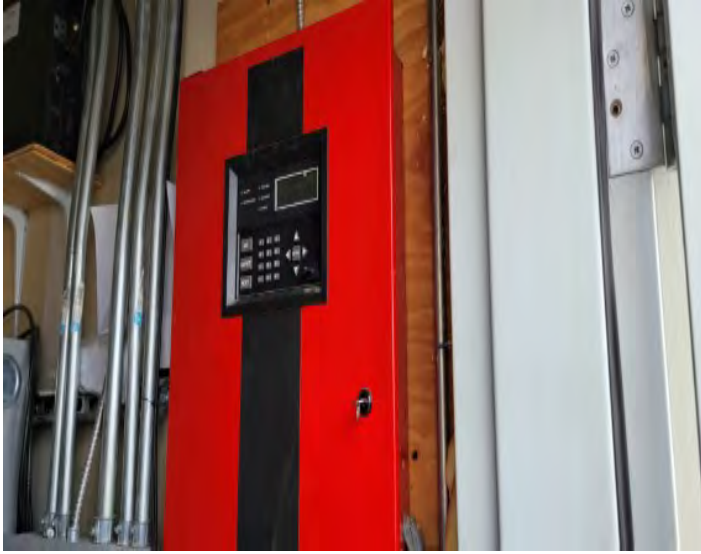
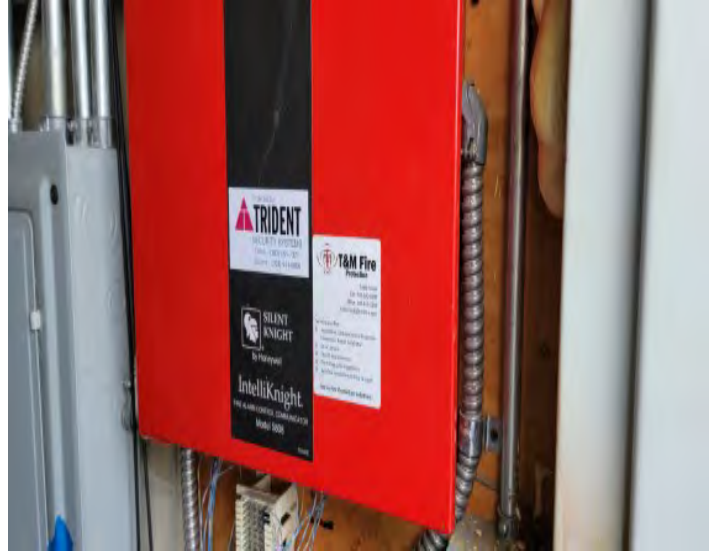
Comp #: 901 Fire Protection System - Replace

- System was recently professionally tested and passed inspection.
- Once the system is installed, it is unlikely that any rewiring will be required; replacement costs reflect replacement of the panels only.
- Expect to replace these panels every 15 - 20 years depending on levels of maintenance and under normal conditions.
- Professionally test at least once a year to ensure proper operation during an emergency situation.

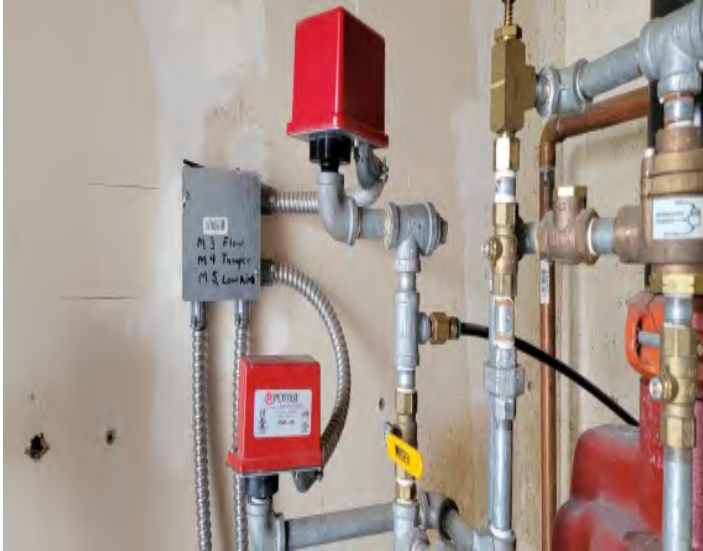
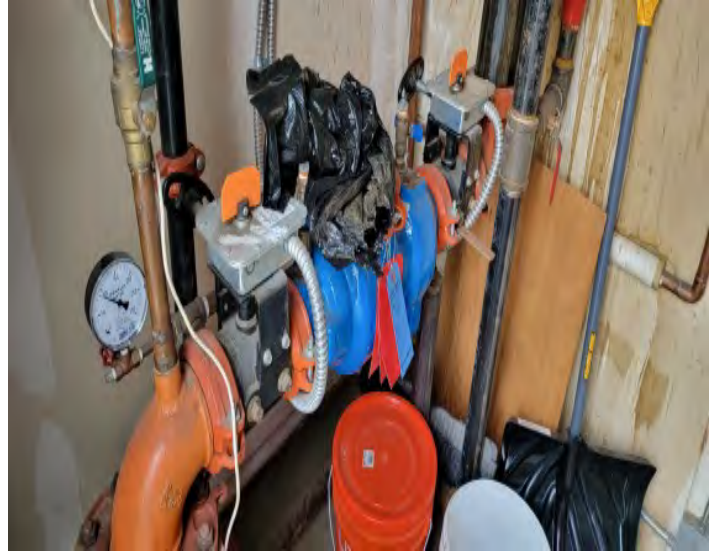
Comp #: 902 Fire Alarm Equipment - Replace

- Lines are connected to the main, there are no separate meters of the system.
- If trouble arises, the system activates in the troubled areas only, not the entire system
- System is inspected every year
- It is not expected that all components of the system will fail at the same time.
- An allowance has been included to replace needed pieces of the system (batteries, valves, gauges, etc.) every 2 years

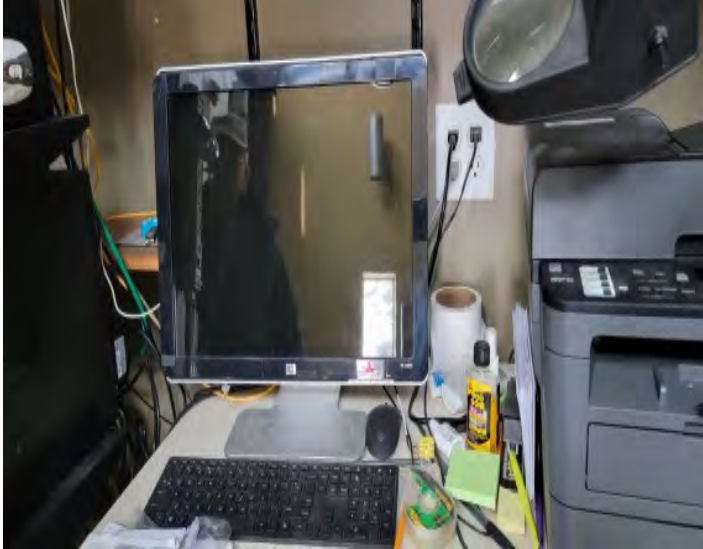
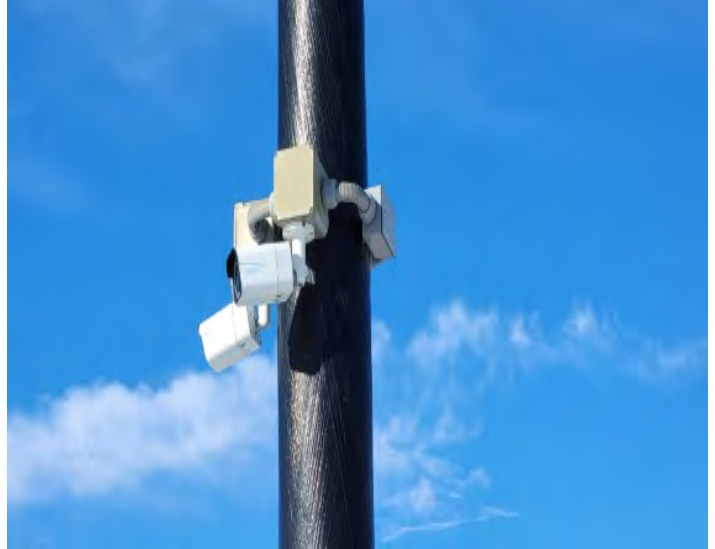
Comp #: 903 Security System - Replace

- Due to advances in technology over the past 5 - 10 years with web based video security, we are finding that associations can download updates to their existing software at little or no cost.
- However, due to improved resolution of cameras, we recommend reserving to replace the monitoring system every 5 - 8 years
- Remaining life is based on assumed age and quality of system

- 2016-2021 - \$30,735 (Replaced analog security system with digital cameras (44) and recorders (6) and fiber optic for new system.)

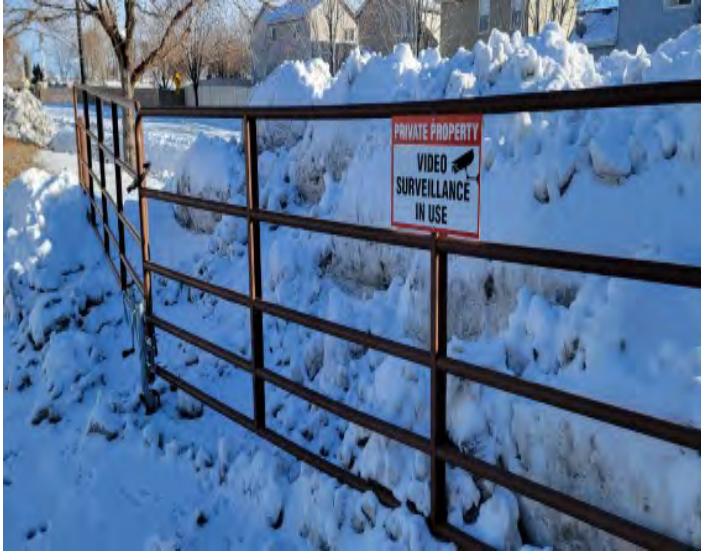
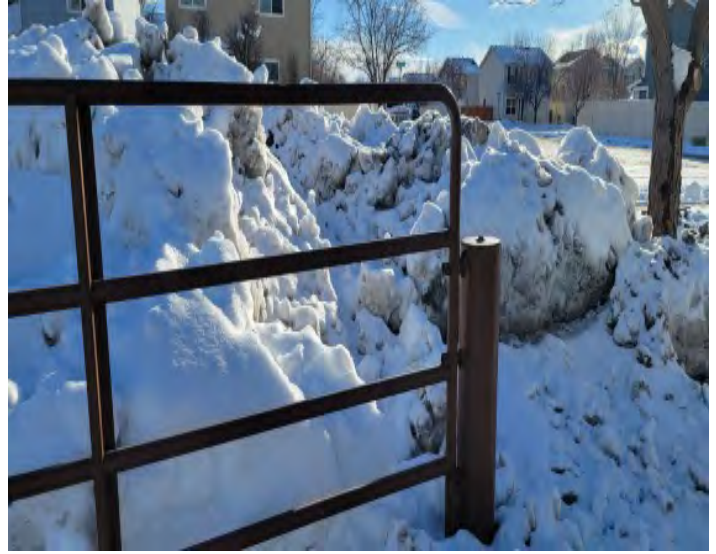
Comp #: 907 Vehicle Gates - Replace

- These gates are heavy duty and should have an indefinite life expectancy under normal conditions.
- At this time, we do not recommend Reserving for replacement due to indefinite life expectancy with proper maintenance

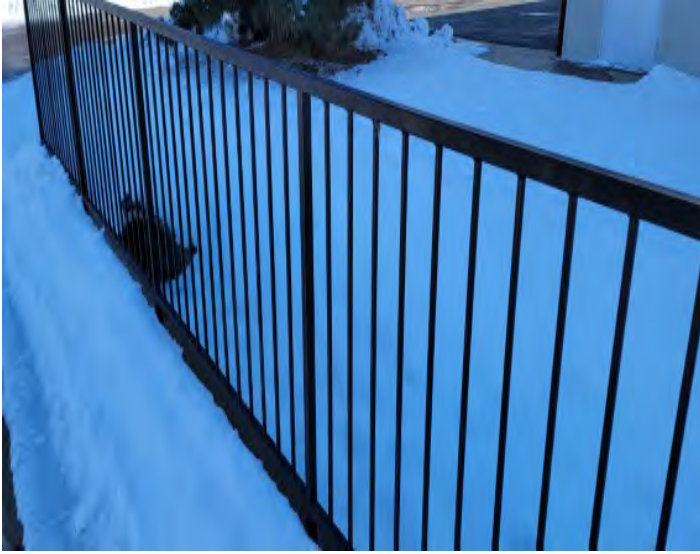
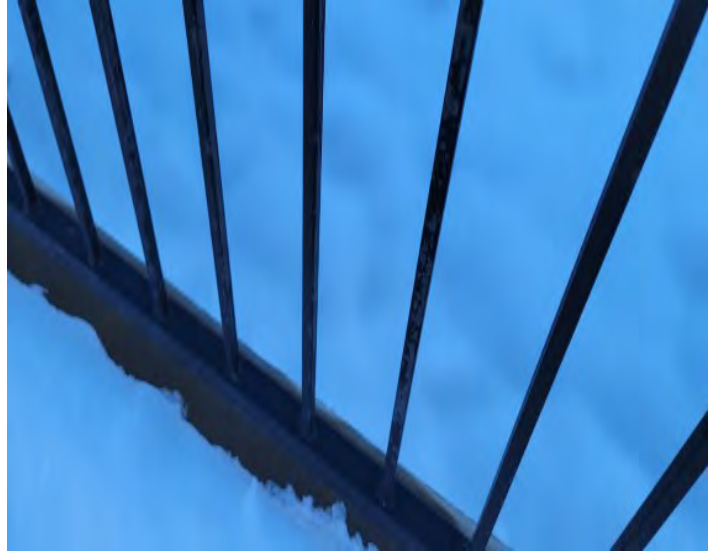
Comp #: 1002 Metal Handrails - Replace

- The base rail and posts were buried in snow at the time of our site evaluation, so we were unable to observe the condition and determine if there was any rusting or corrosion along the bottom of the railings. Of the areas that were exposed, there were no unusual conditions noted.
- The average life expectancy for metal rails ranges between 25 - 30 years, depending on maintenance schedules and exposure to elements.
- The remaining life is based on age of rails and observed conditions.

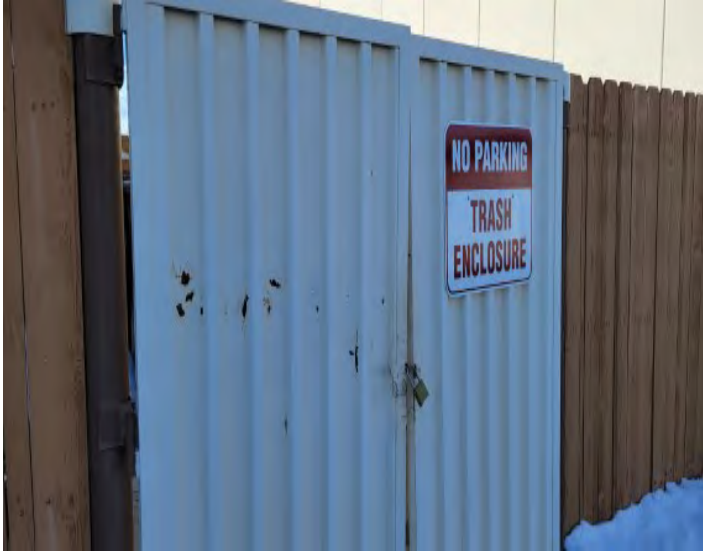
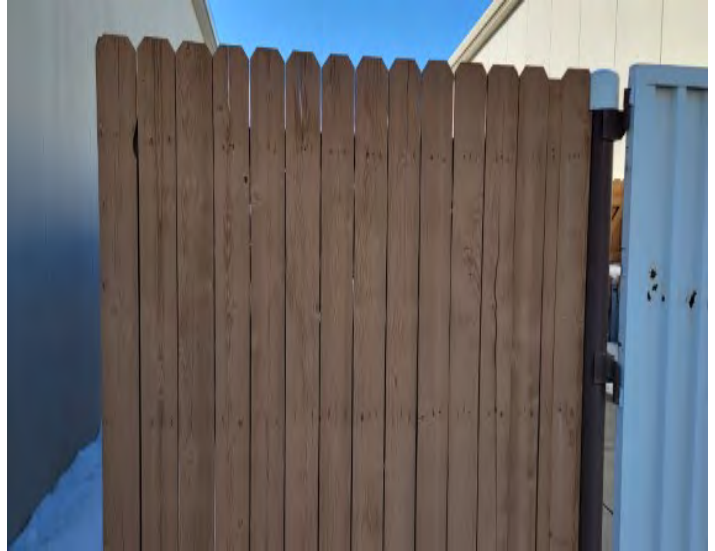
Comp #: 1010 Trash Enclosures - Replace

- There was some damage observed on the metal gates, but wood fence was sturdy and in very good condition.
- Expect frequent repairs and replacement to the gates and possibly the fencing due to the exposure to elements and probability of abuse from rubbish companies.
- In our experience, we typically see the need for repairs every 5 - 15 years, depending on the level of abuse.
- Based on age and observed condition, we established a replacement cycle of 15 years at this time.

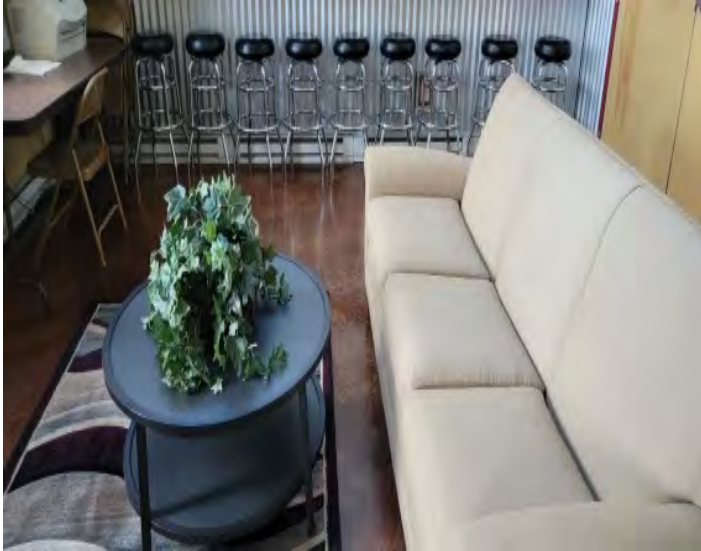
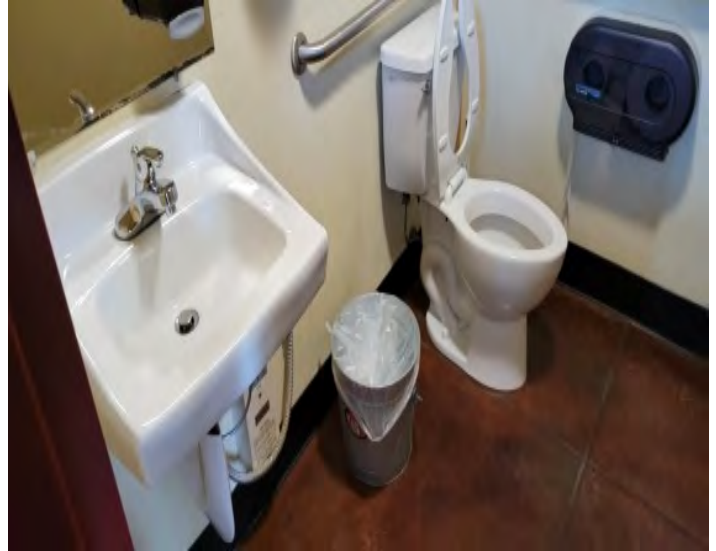
Comp #: 1413 Clubhouse - Periodic Upgrades

- This line item is a small allowance to replace needed furnishings or equipment every 5 years.
- See component #1414 for a major upgrade and refurbishment every 25 years
