Level 1, Platinum Reserve Analysis

Garage Town at Del Camino Storage Co., Inc.
3656 Stagecoach Rd.
Longmont, CO. 80504

FINAL VERSION

Date of Property Observation – January 6, 2023

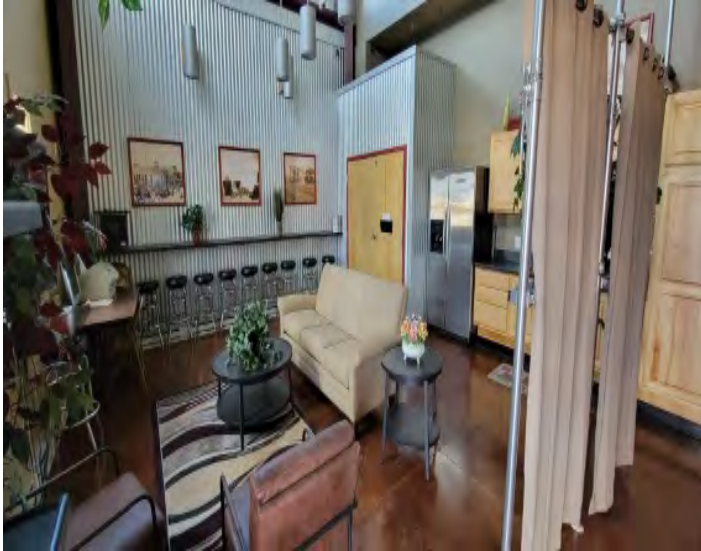
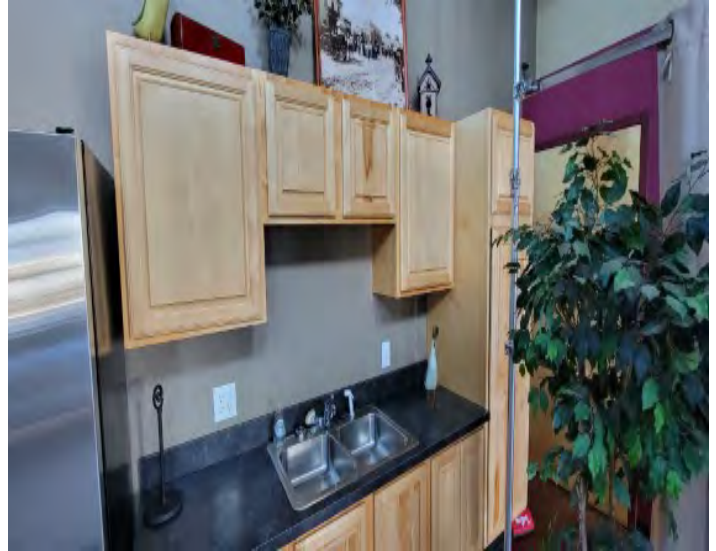
Comp #: 1414 Clubhouse Room - Major Remodel

- Expect to refurbish and perform a major remodel this clubhouse room every 25 - 30 years to maintain appearance and keep up with changing decorative trends.
- On a separate line item, (see component #1413), we have also included a small allowance to replace needed items every 5 years.
- Remaining life based on age of clubhouse and current observed condition

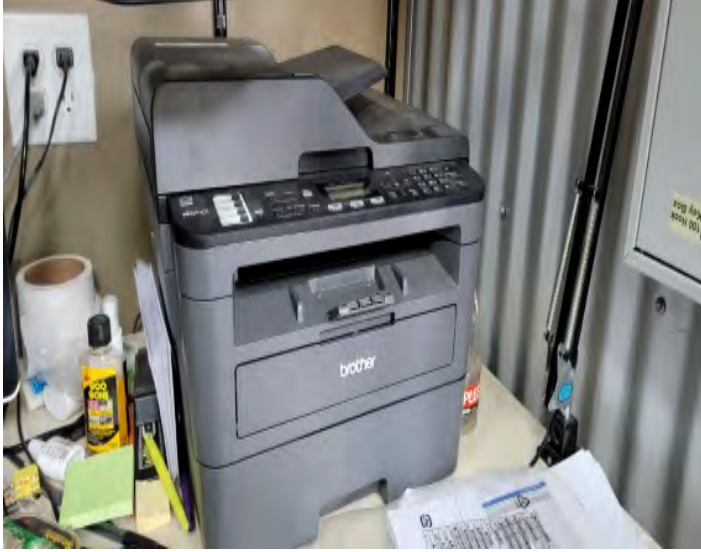
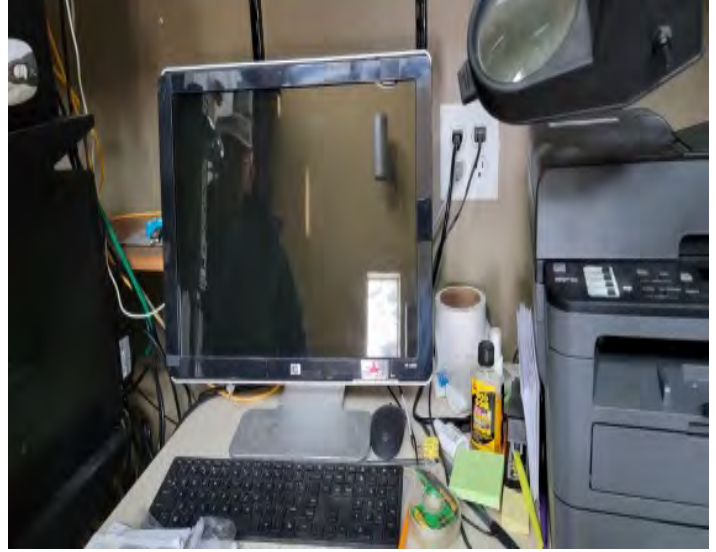
Comp #: 1417 Office Equipment - Replace

- We have established an allowance to replace needed equipment every 6 years.

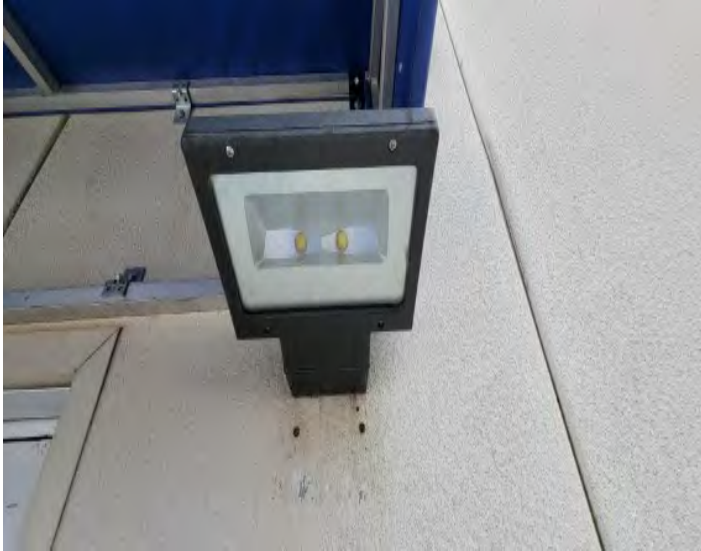
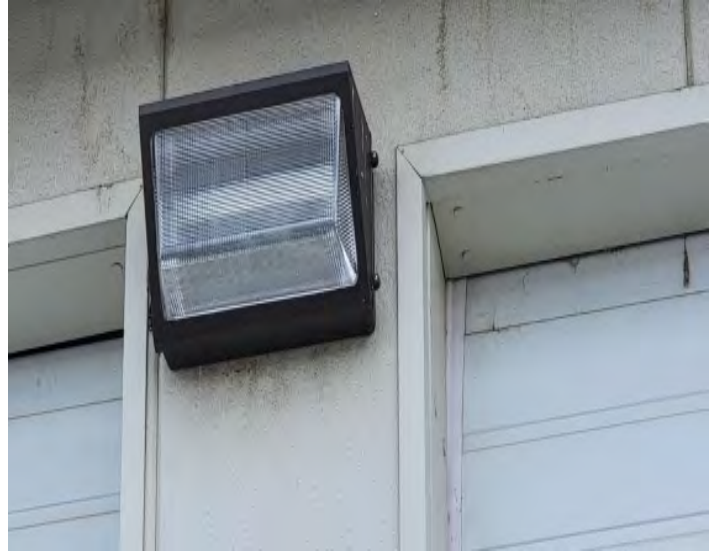
Comp #: 1602 Exterior Wall Pak Lights - Replace

- Association replaced vapor lights with LED about 7 - 9 years ago.
- While replacement can occur on an as needed basis, it is our opinion and recommendation to replace all lights at the same time every 10 - 15 years to maintain a consistent appearance throughout the property.
- By replacing multiple fixtures, the association will be able to obtain a quantity discount for replacement and installation of the fixtures. - This will also ensure a consistent appearance for the community by replacing all at the same time.

- 2014-2016 - \$8,500 (Replaced multi vapor exterior lighting with LED wall packs.)

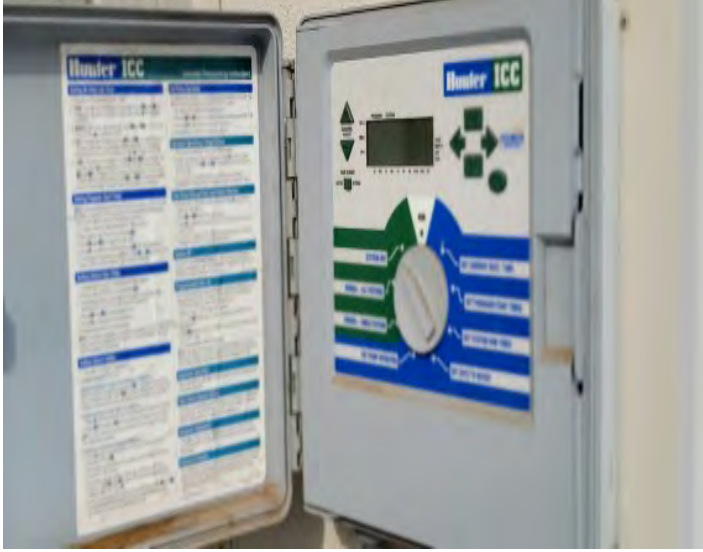
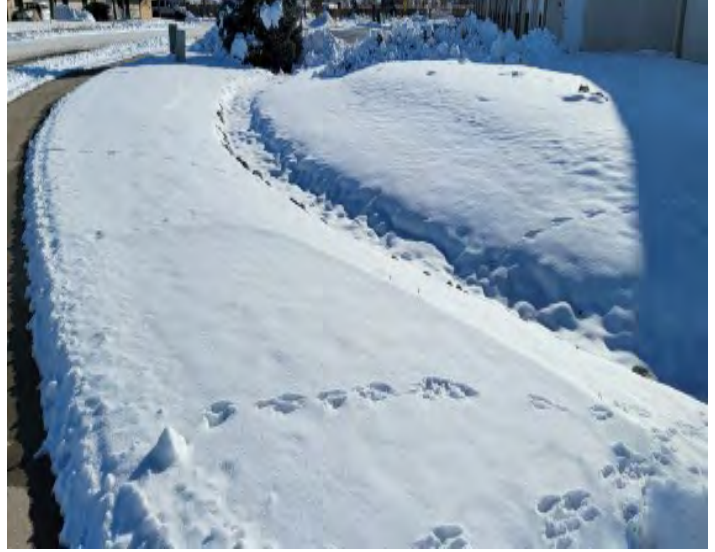
Comp #: 1701 Irrigation System - Major Repairs

- System has been decommissioned since the association converted all the grass areas to rock and xeriscape.
- Since the system is not no longer functional, Reserve funding is not required

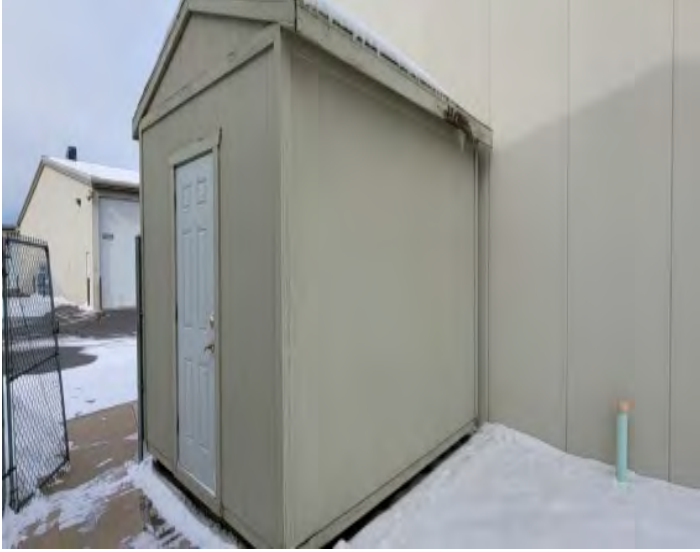
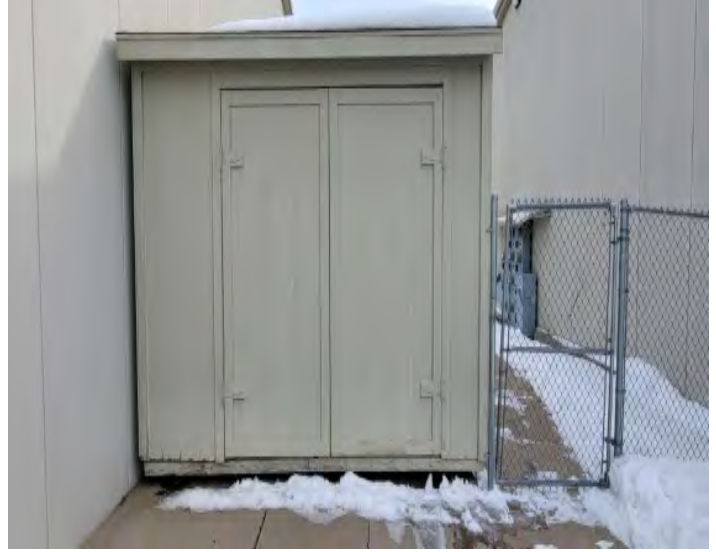
Comp #: 1904 Storage Shed - Replace

- We recommend painting every 5 - 6 years as an operating expense to protect the materials from exposure to elements that can cause deterioration.
- As long as proper maintenance occurs and there is limited exposure to elements (snow and ice buildup), then the replacement cycle of these sheds ranges from 20 - 25 years
