Level 1, Platinum Reserve Analysis

Garage Town at Del Camino Storage Co., Inc.
3656 Stagecoach Rd.
Longmont, CO. 80504

FINAL VERSION

Date of Property Observation – January 6, 2023

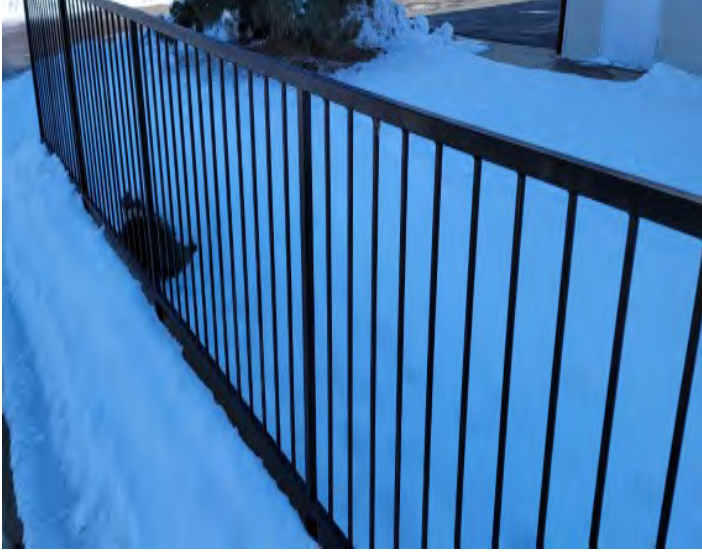
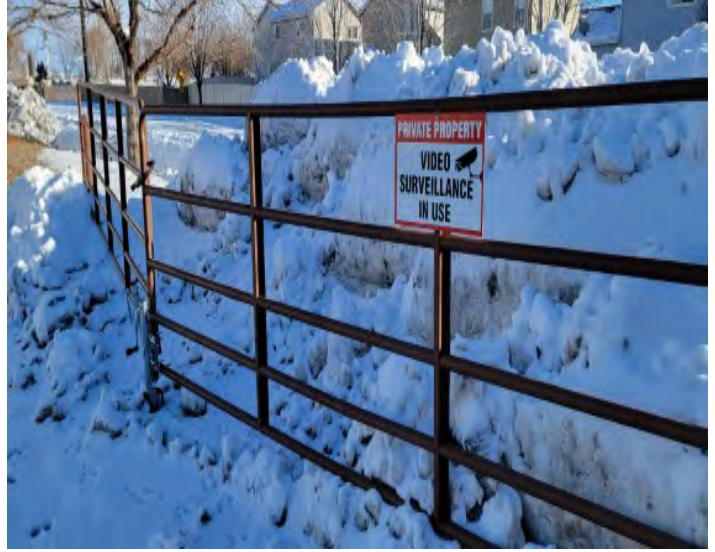
Comp #: 212 Metal Surfaces - Repaint

- Area is too small for reserve designation.
- Repaint on an as needed basis with general operating funds.

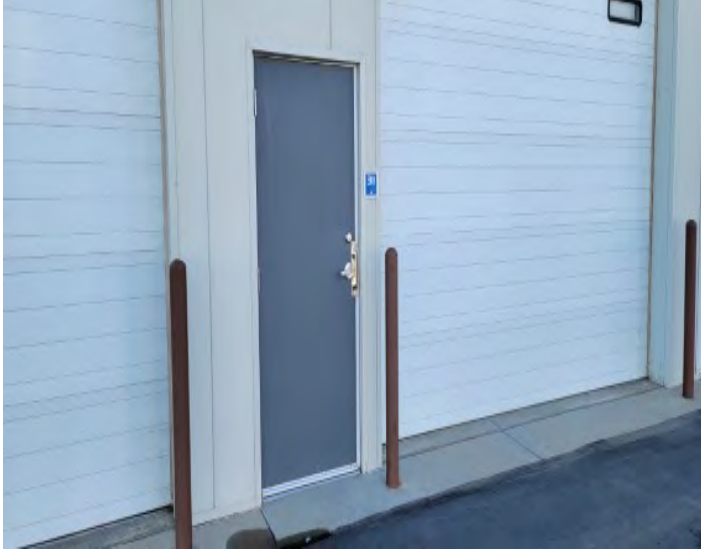
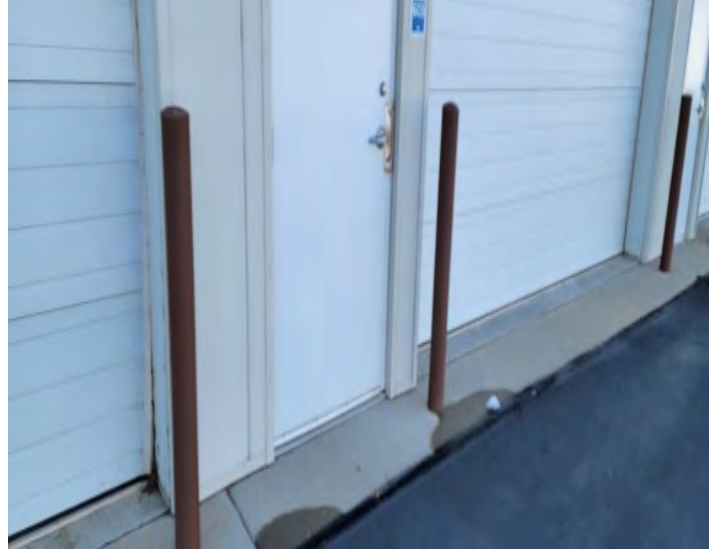
Comp #: 217 Doors/Bollards - Repaint

- These surfaces should be painted every 4 - 5 years to protect the materials from exposure to elements and to maintain appearance.
- It was reported the unit owner is responsible for painting the unit man doors and the bollards adjacent to their unit.
- Therefore, separate Reserve funding is not required for this component

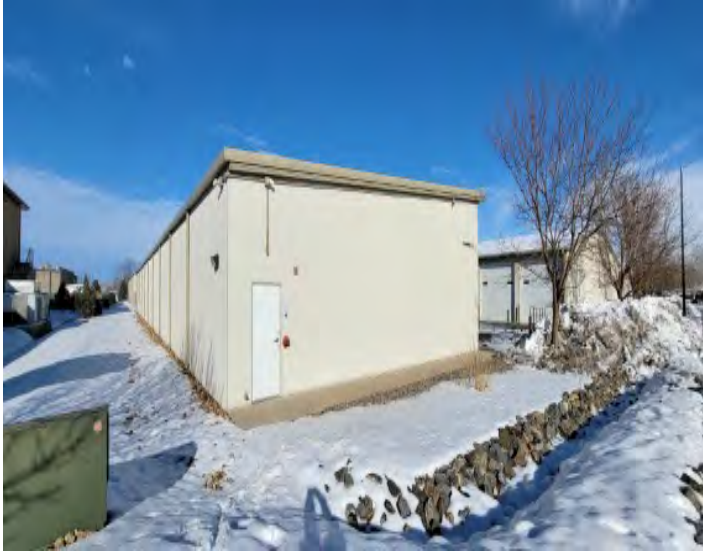
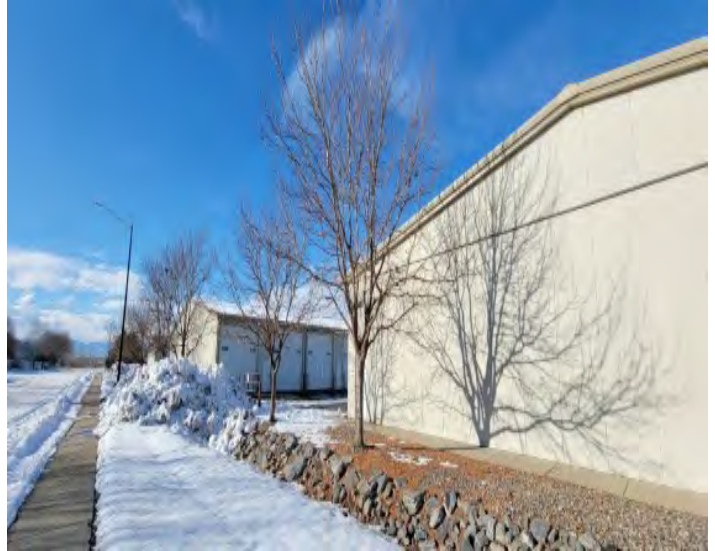
Comp #: 1801 Groundcover/Trees - Replenish

- There is very little "groundcover" such as plants.
- Typically, associations will establish a line item in the operating budget to handle annual replenishment of any landscaping
- Therefore, separate Reserve funding is not necessary since funding has been established in a separate budget.
- If the association prefers to include a funding allowance for additional groundcover replenishment, then we would need to know how much and how often the current board of directors would prefer to set aside since this would be considered a discretionary expense.
